**AVONDALE HOMEOWNERS ASSOCIATION
TREE ASSESSMENT REPORT
APRIL 16, 2024**

Legacy Arborist Services (LAS) has completed an assessment of the condition and risk level of all trees residing within the designated common areas of the HOA property as indicated on the following map.

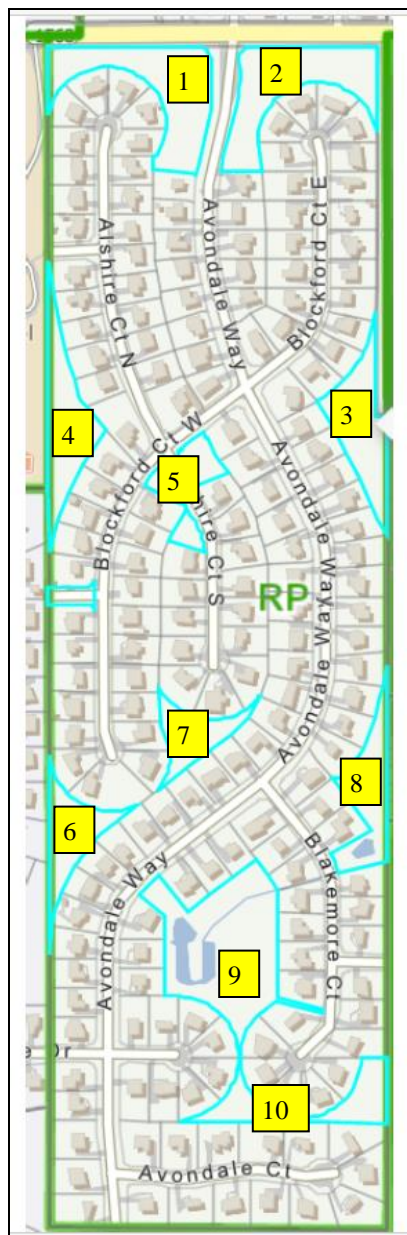
1. Entrance West
2. Entrance East
3. Nabb Road
4. Blockford West/Chelsea
5. Alshire
6. Blockford SW
7. Blockford SE
8. Blakemore
9. Lower Avondale
10. Blakemore SW

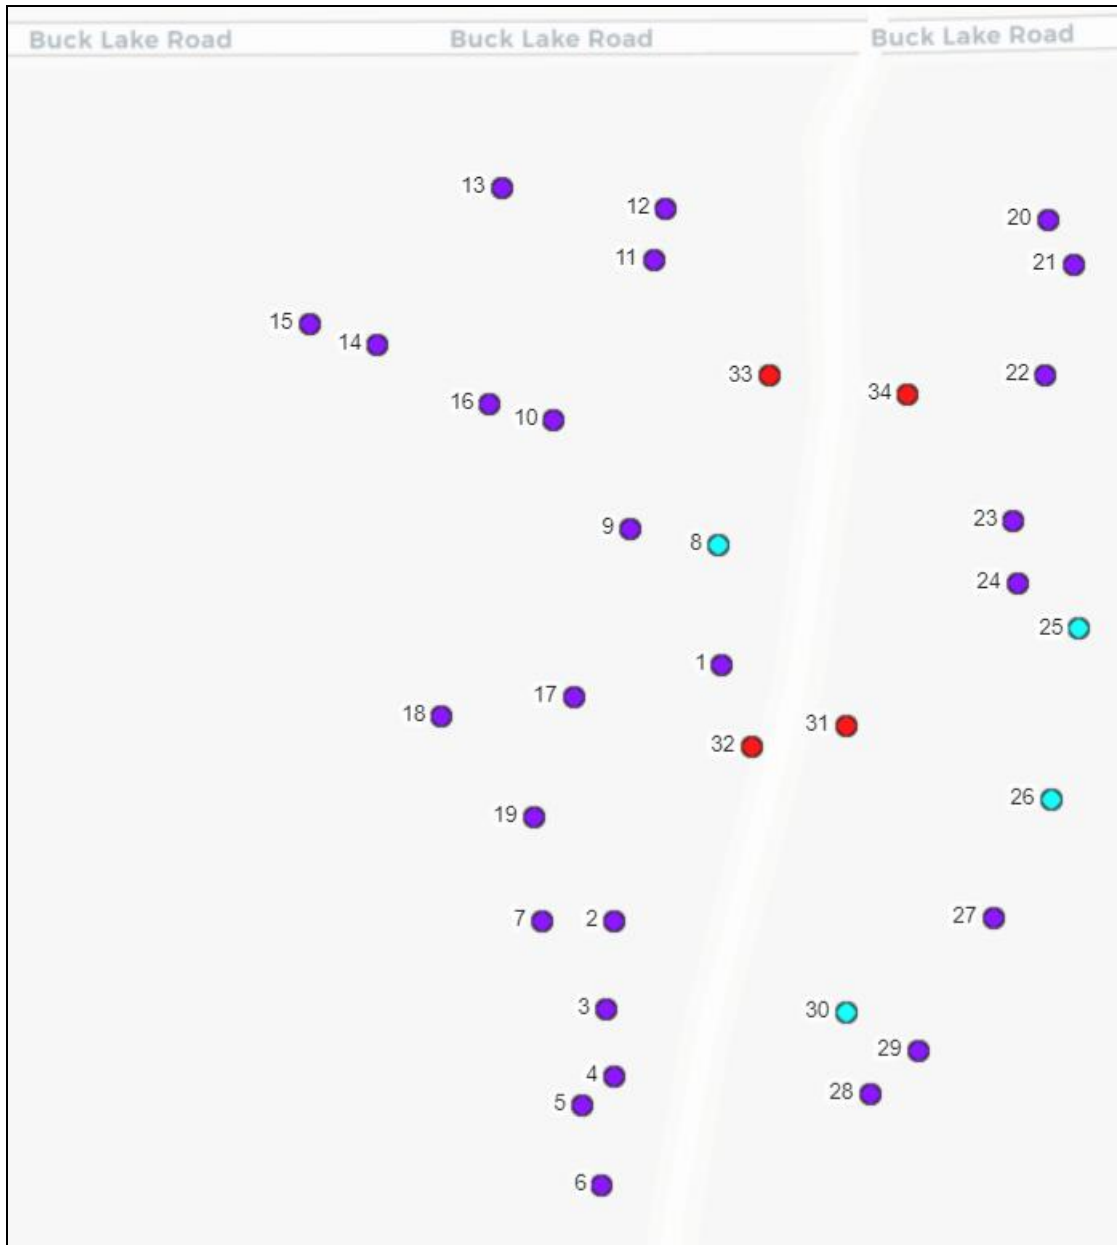
- Other (4)
- Priority 1 Removal (2)
- Priority 2 Removal (8)
- Remove Tree (49)

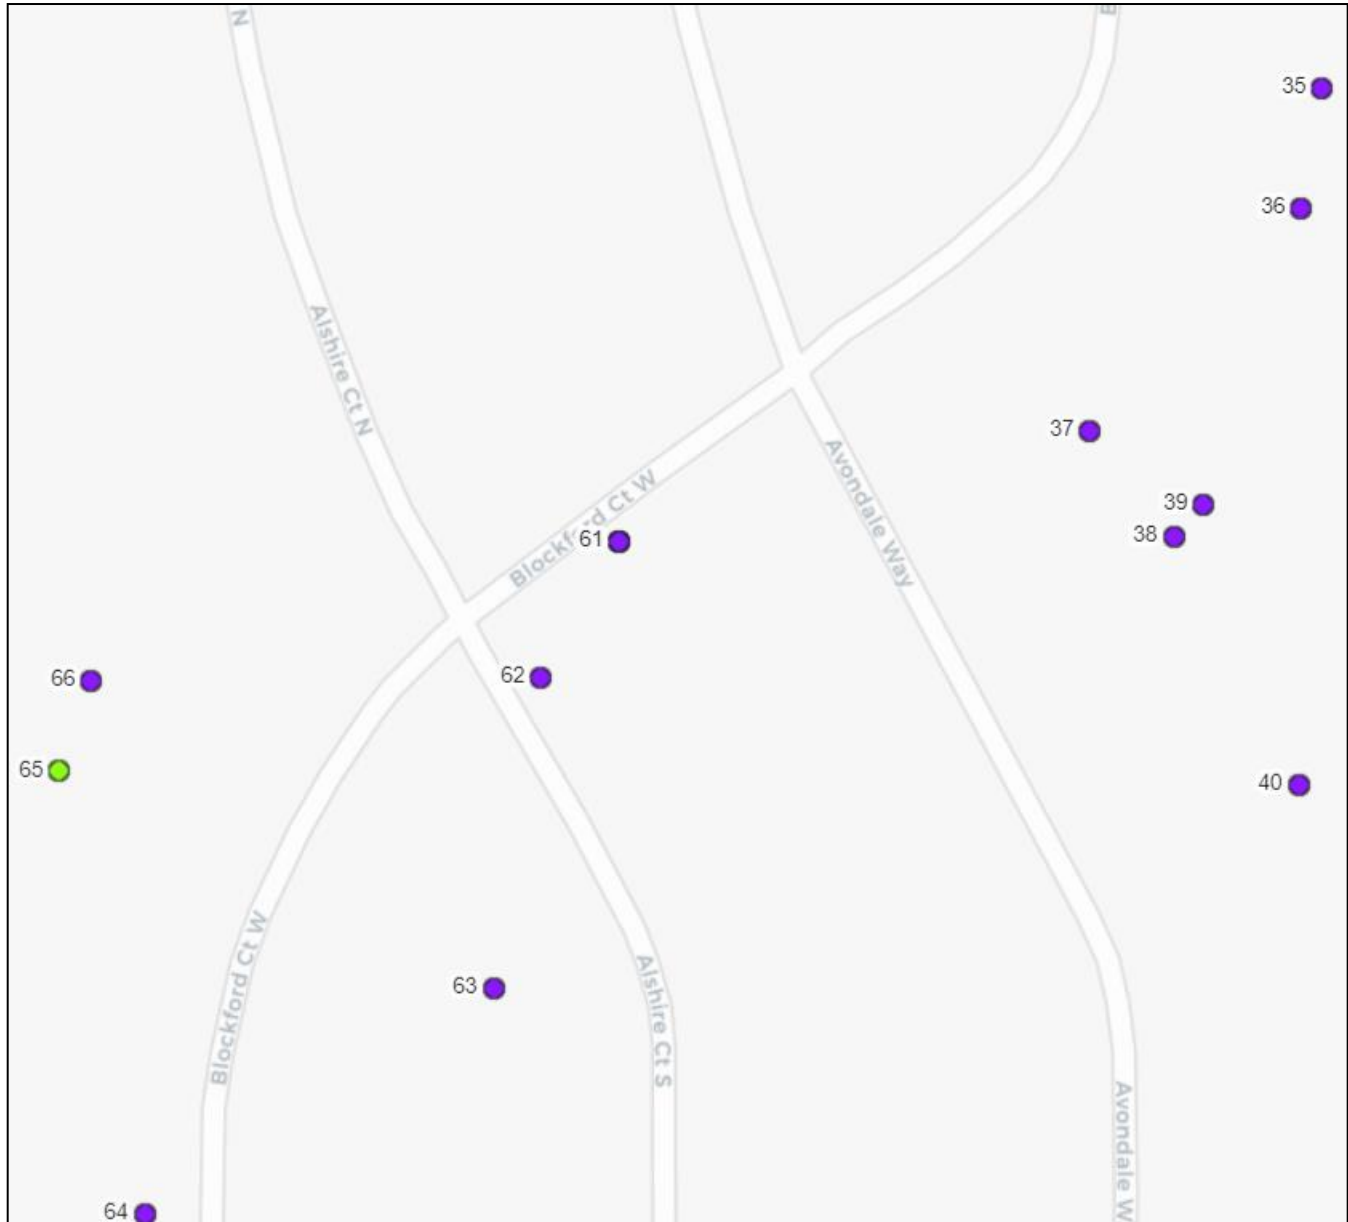
- Other (4)
- Priority 1 Removal (2)
- Priority 2 Removal (8)
- Remove Tree (49)

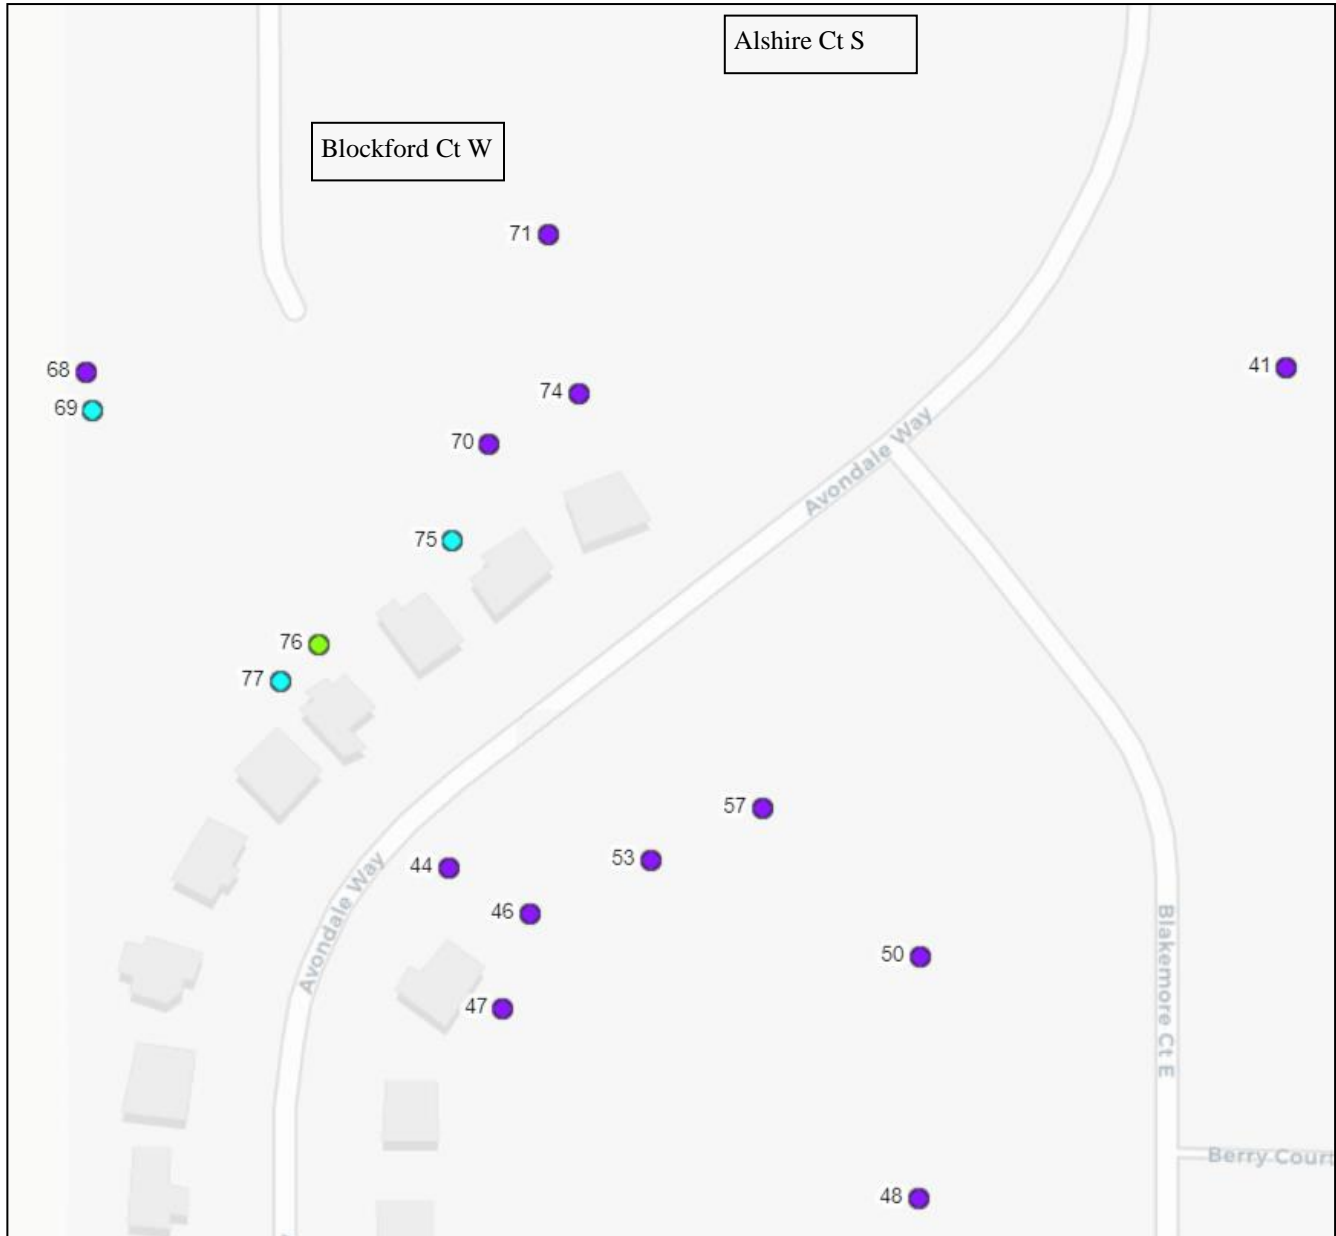
- Other (4)
- Priority 1 Removal (2)
- Priority 2 Removal (8)
- Remove Tree (49)
